Ocean Engineering Studies

Volume V: Acrylic Windows— Spherical Shell Configurations

J. D. Stachiw

PUBLISHED BY
NAVAL OCEAN SYSTEMS CENTER
SAN DIEGO, CALIFORNIA

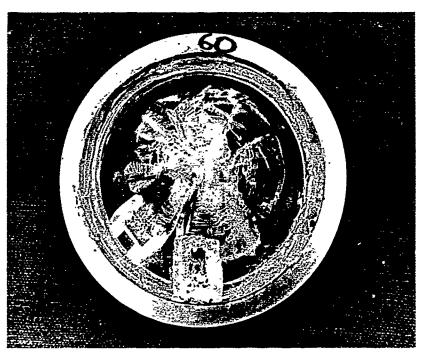
Figure 19. 30 $^{\circ}$ spherical sector window with square edge after being subjected to short-term hydrostatic pressure of sufficient magnitude to initiate crack formation without catastrophic implosion.

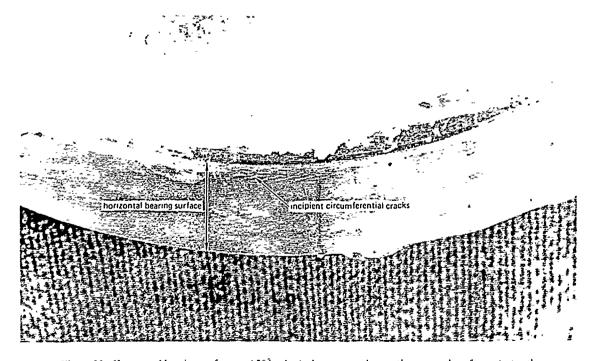
Figure 23. Horizontal bearing surface on 120° spherical sector window with square edge after catastrophic implosion. Note the presence of a few circumferential cracks in the bearing surface.

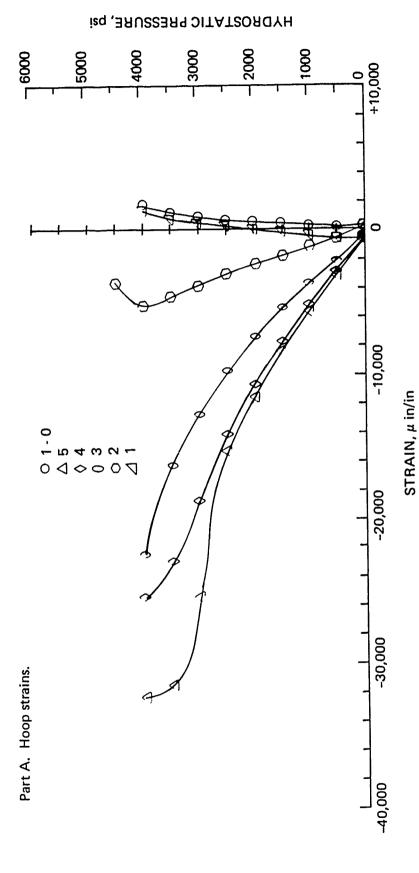
Figure 30. 120° spherical sector window with square edge and $t/R_1 = 0.159$ (figure 8) under short-term hydrostatic loading.

Strains in windows with square edges were fairly linear to approximately 2500 psi of hydrostatic loading (figures 27 through 33). Above that value, they became highly nonlinear and in many cases reversed direction. The meridional strains in particular indicated large-scale bending occurring around the periphery and at the center of the window. Bending around the periphery was deduced from the observation that the meridional compressive strain on the convex surface of the window around its periphery (location 1-0)* generally showed only a small increase with pressure (or even became positive), while the meridional compressive strain on the concave surface of the window around its periphery (location 1) showed a rapid increase with pressure. Flattening of the window's center was deduced from observation of the meridional strain at the center of the concave surface. This strain

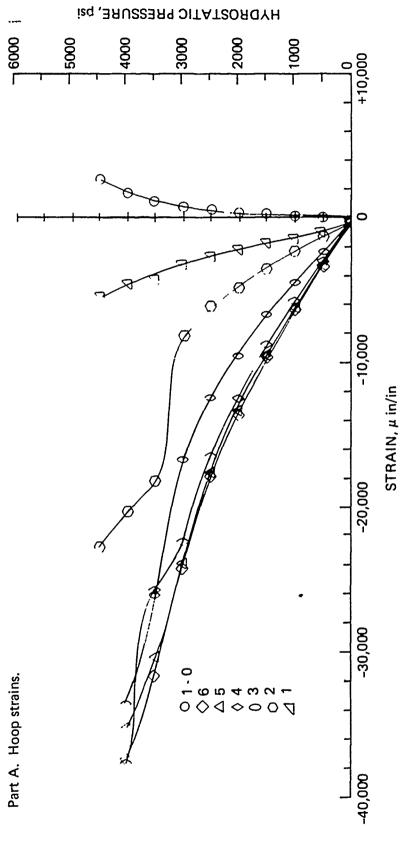
Figure 32. 150° spherical sector window with square edge and $t/R_{\rm i}$ = 0.159 (figure 10) under short-term hydrostatic loading.

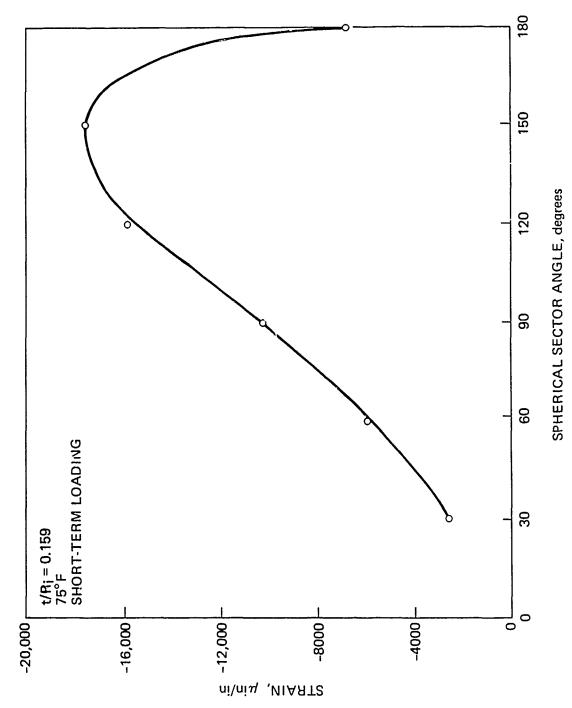
Figure 34. Relationship of spherical angle to meridional strain on concave surface around periphery of spherical sector windows with square edges and $t/R_1 = 0.159$ subjected to 1200-psi short-term hydrostatic loading.

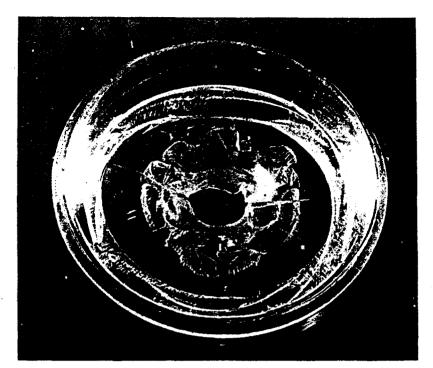
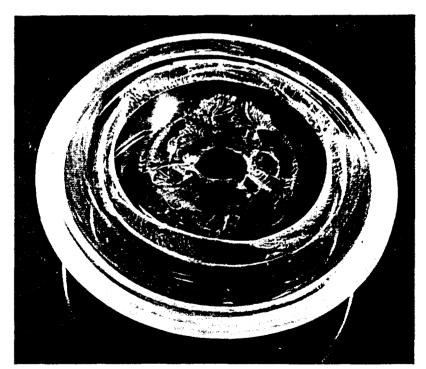
Figure 45. 120° spherical sector window with square edge after implosion, which occurred after 800 hours of sustained hydrostatic loading at 2500 psi.

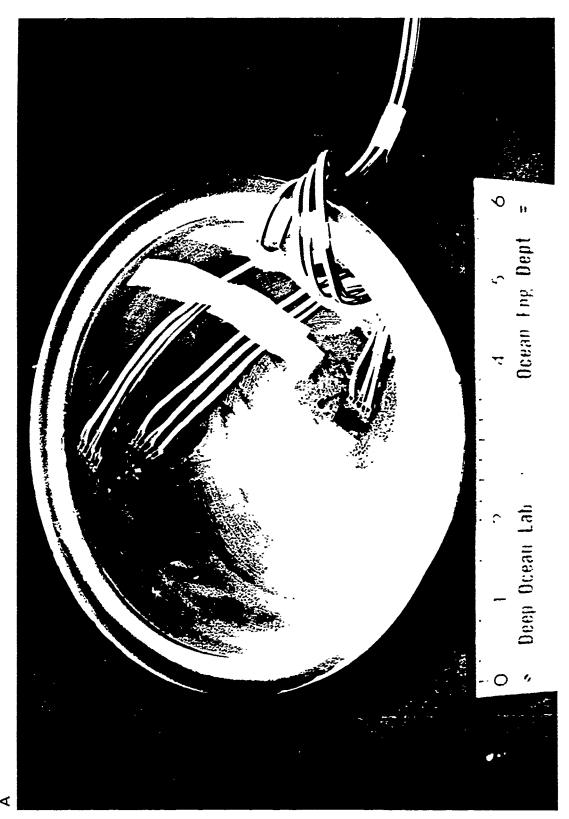
Figure 5. Installation of Strain Gages on the Interior Surface of the Shell Specimen; (A) overall view, (B) close up.

On one specimen of each thickness and type, electric resistance strain gages were installed on the interior of the shells (figure 5). The three-element rosette gages (Baldwin Lima Hamilton, FAER-12RB-12S6ET) were bonded to the inside shell surface with Eastman 910 cement at the apex, at a 20-degree elevation above the flange, and at the flange. Water proofing (BLH Gagecote 1) and silicone RTV completed the installation.

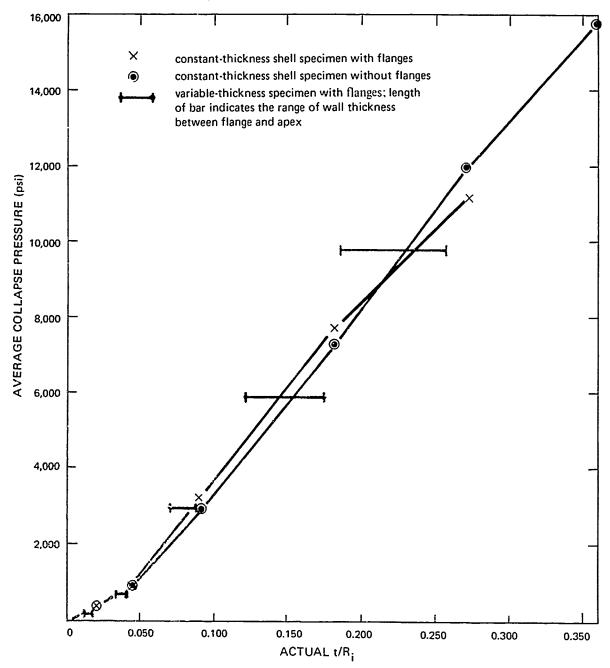
Figure 8. Collapse Pressure Versus t/R₁ Ratio for Hemispherical Shells.

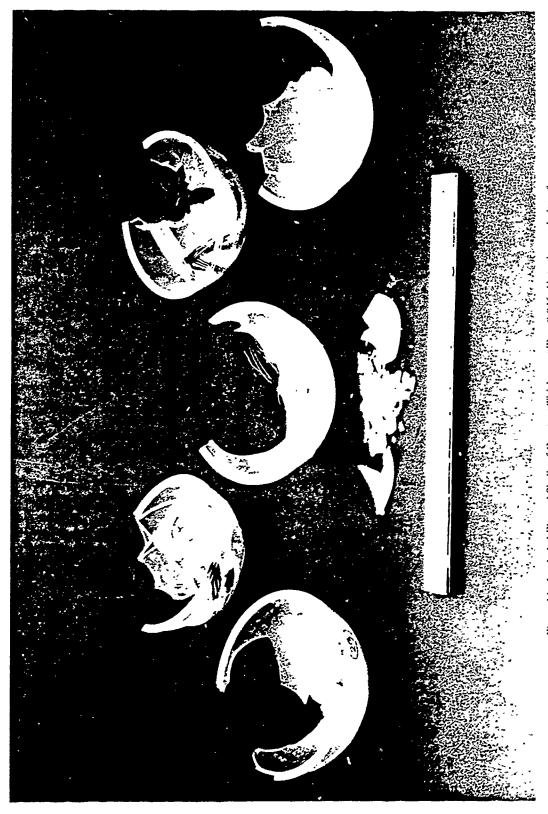
Figure 11. Imploded Flanged Shells of Constant Thickness; $t/R_1 = 0.046$. Note the regularity of the local fadure pattern and the location of its center at 45 degrees of elevation.

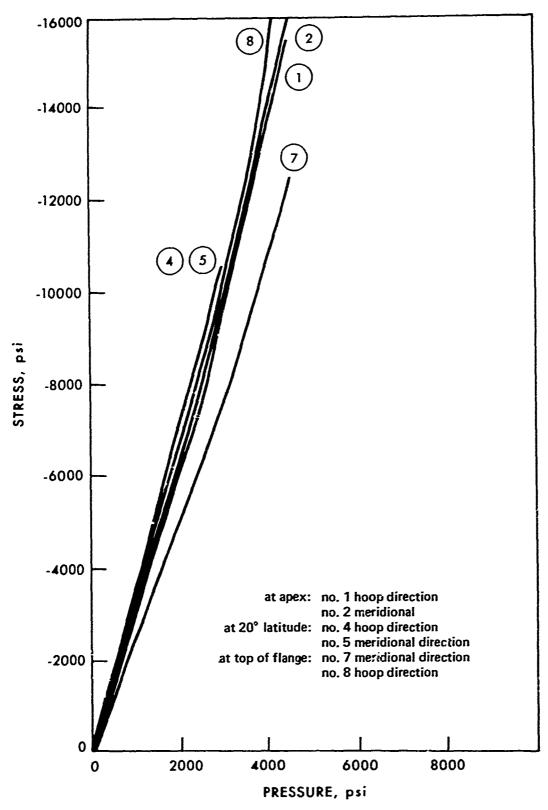
Figure 14. Stress Measured on the Interior of a Flanged Window of Constant Thickness; $t/R_{\tilde{I}} = 0.182$.

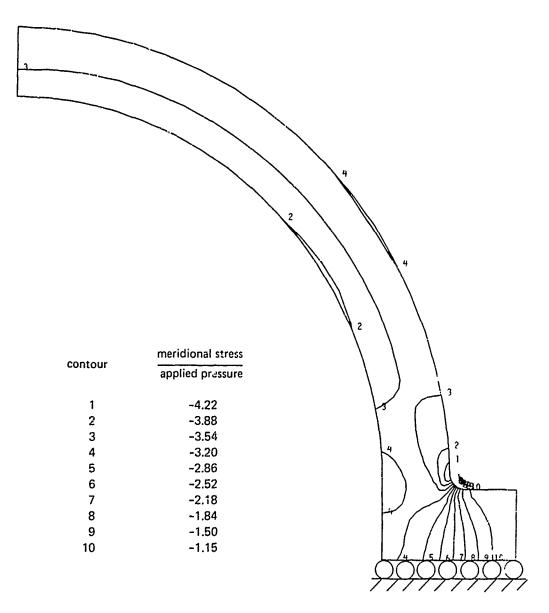
Figure 16. Meridional Stresses in a Flanged Shell of Constant Thick...ss With Free-Sliding Boundary Condition; $t/R_i = 0.182$.

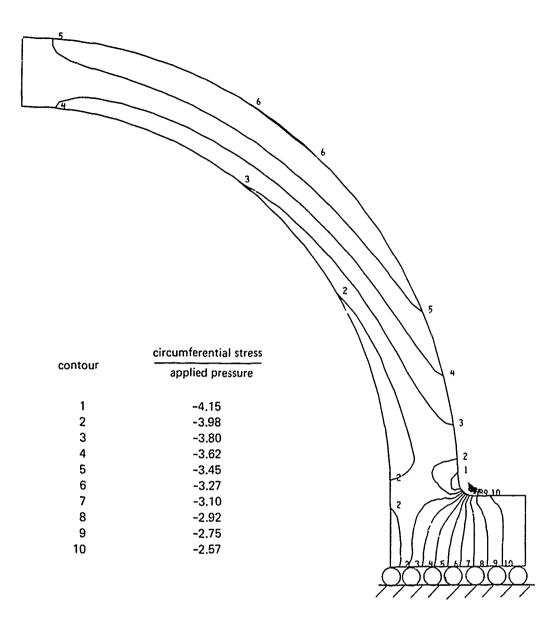
Figure 17. Circumferential Stresses in a Flanged Shell of Constant Thickness with Free-Sliding Boundary Condition; $t/R_i = 0.182$.

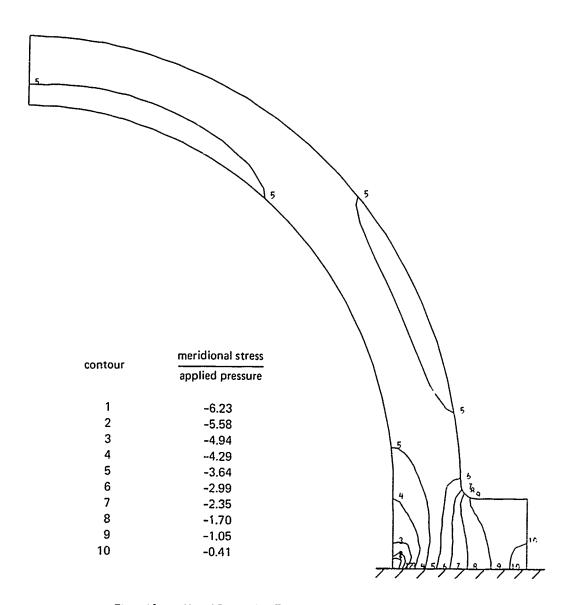
Figure 18. Meridional Stresses in a Flanged Shell of Constant Thickness with Restrained Boundary Condition; $t/R_i = 0.182$.

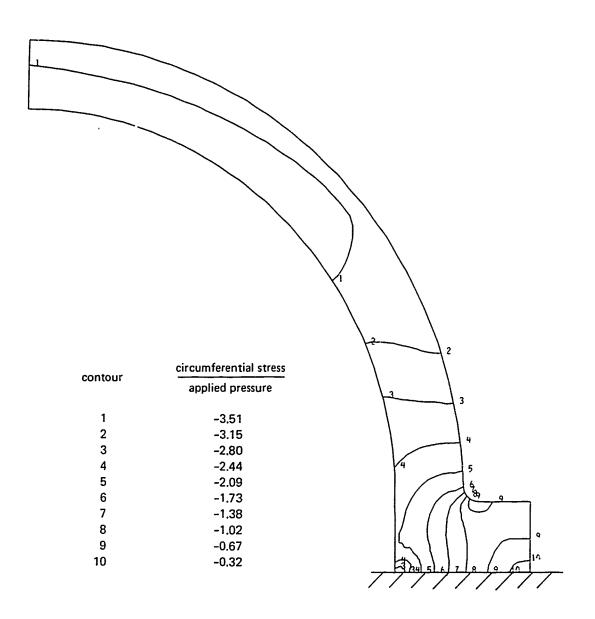
Figure 19. Circumferential Stresses in a Flanged Shell of Constant Thickness With Restrained Boundary Conditions; $t/R_i = 0.182$.

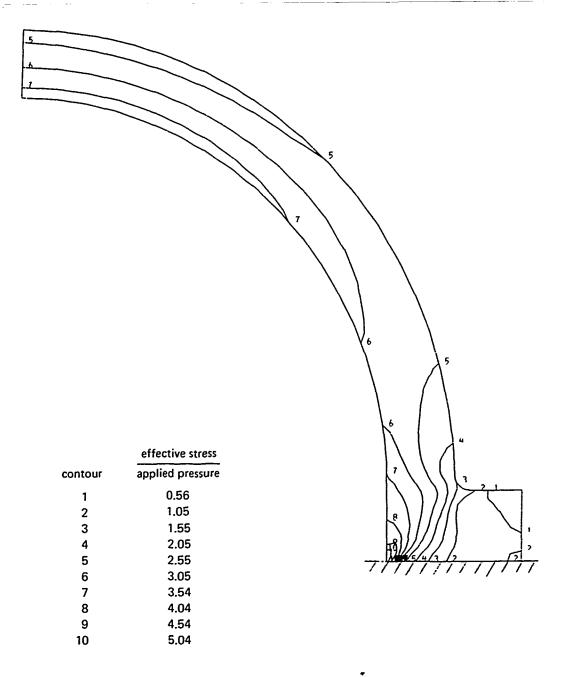
Figure 22. Effective Stresses in a Flanged Shell of Constant Thickness With Restrained Boundary Condition; $t/R_i = 0.182$.

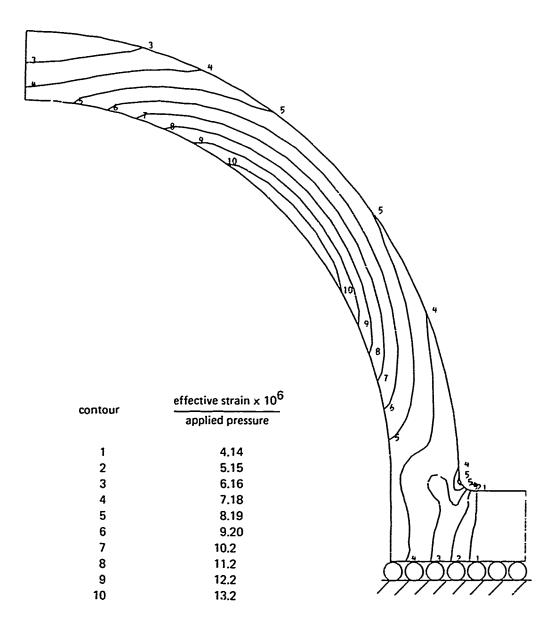
Figure 23. Effective Strains in a Flanged Shell of Constant Thickness With Free-Sliding Boundary Condition; $t/R_i = 0.182$.

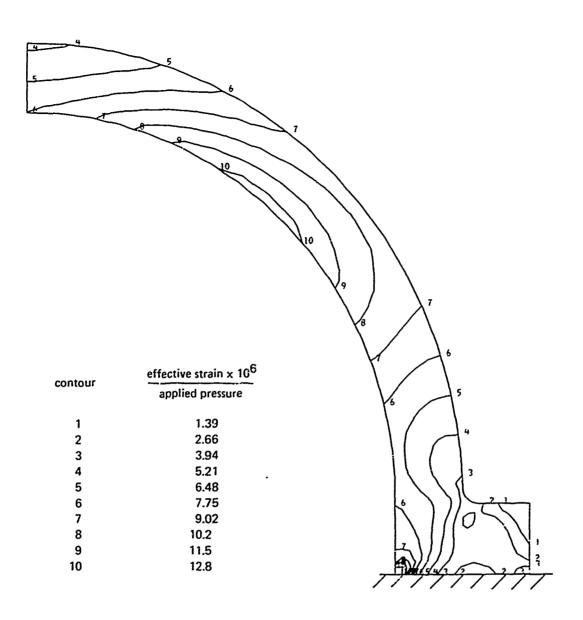
Figure 24. Effective Strains in a Flanged Shell of Constant Thickness With Restrained Boundary Condition: $t/R_i = 0.182$.

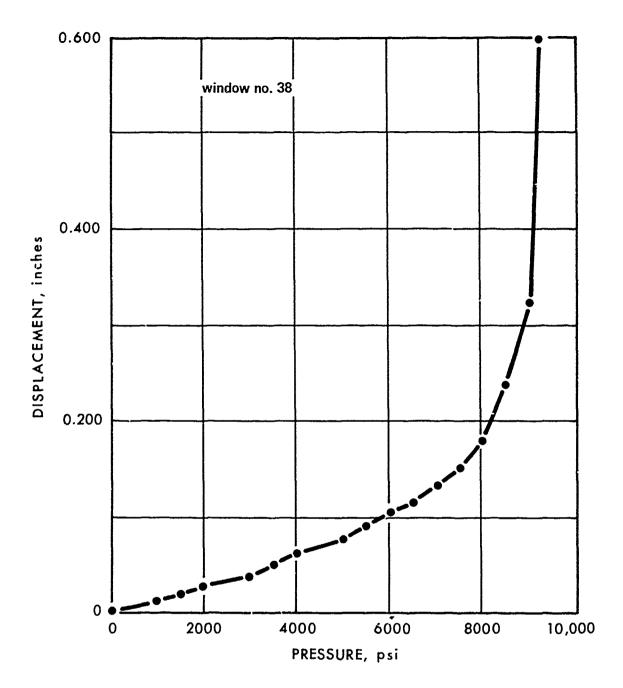
Figure A.4.B. Axial Displacement of a Flanged Shell of Variable Thickness ($t/R_i = 0.273$).

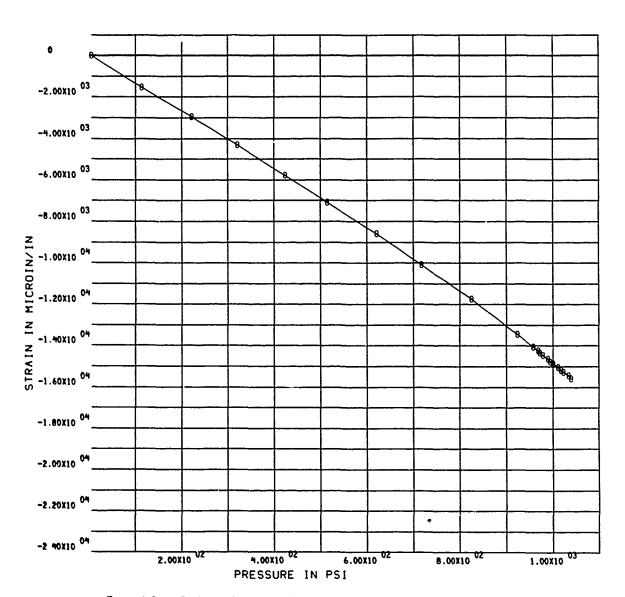
Figure A.5.A. Strain on the Interior Surface at the Apex of a Flangeless Shell of Constant Thickness ($t/R_i = 0.046$) Under Short-Term Hydrostatic Loading.

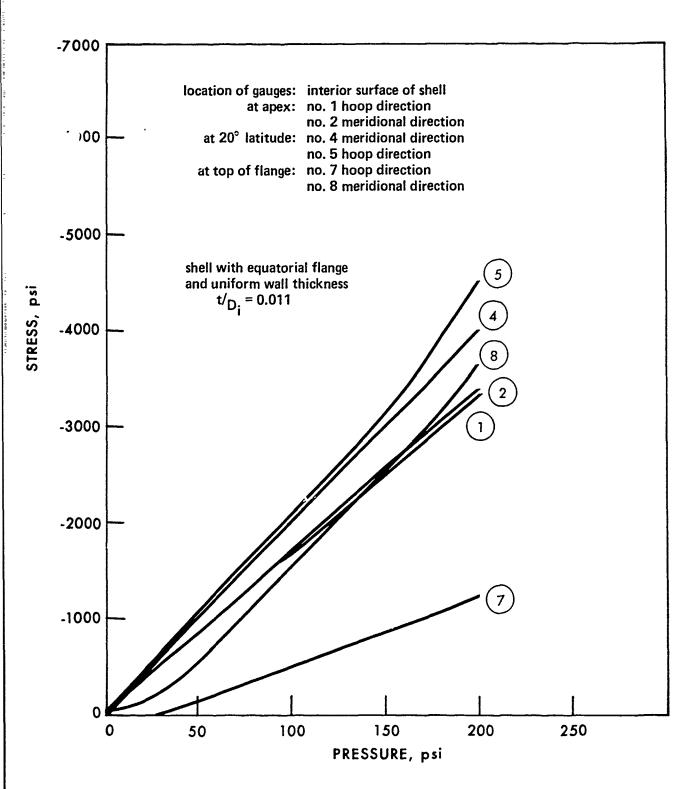
Figure A.8.A. Measured Stresses on the Interior Surface of a Flanged Shell of Constant Thickness ($t/R_i = 0.022$).

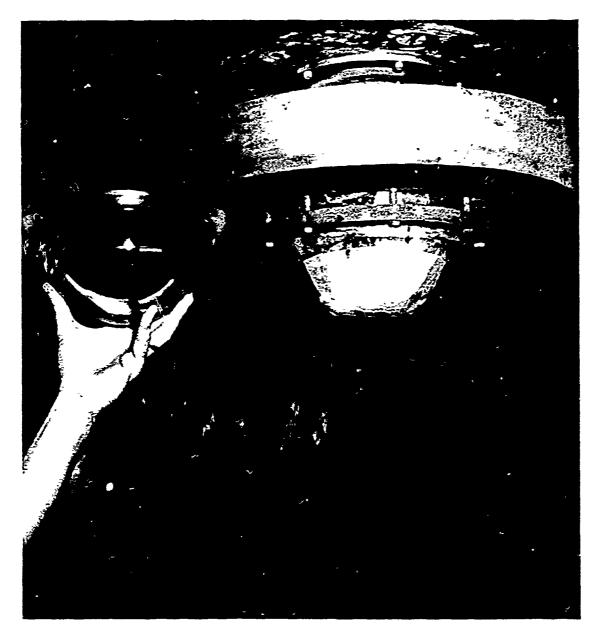
Figure 8. Retaining ring for Type VI window testing in 18-inch-diameter pressure vessel; window V after 42 hours at 11,800-psi sustained hydrostatic loading.

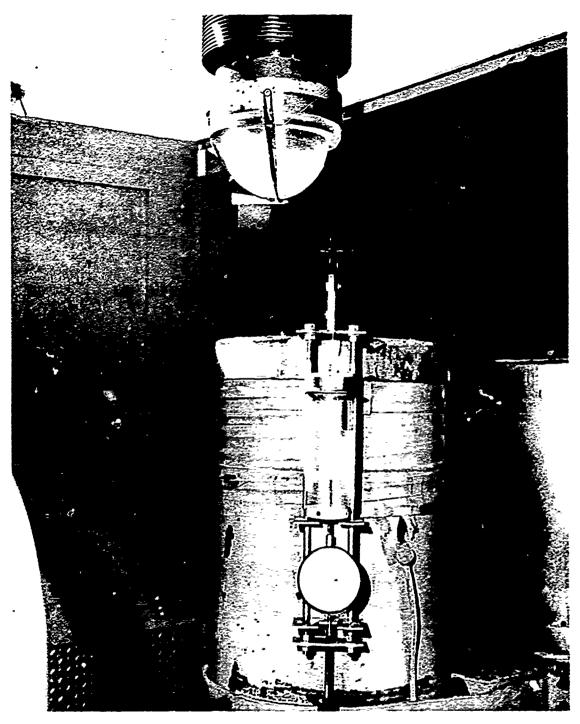
Figure 9. Retaining rubber bands for testing of windows in 9.5-inch-diameter pressure vessel.

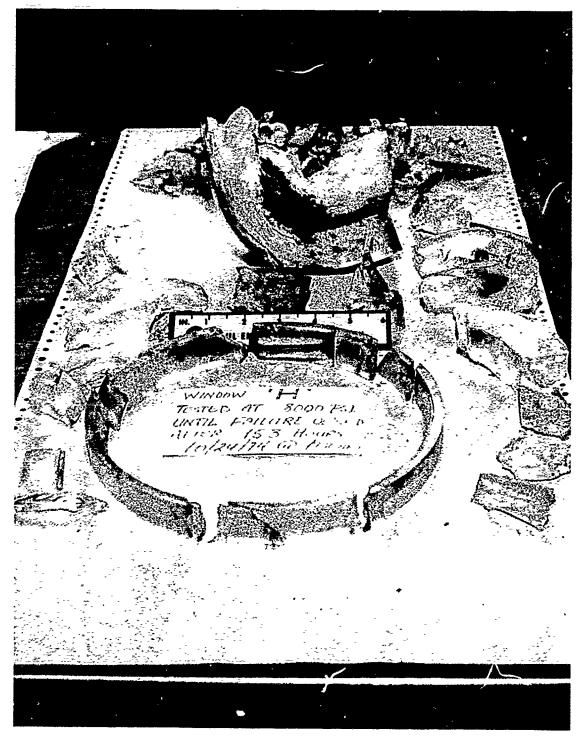
Figure 18. Window H, Type I after 153 hours of sustained pressure loading at 8,000 psi; note the separation of flange.

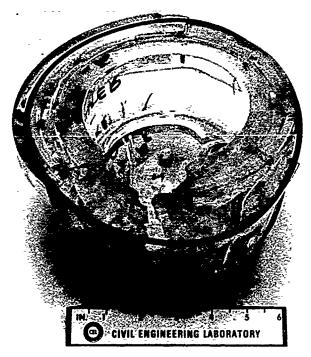
Figure 20. Window R, Type VI after 30 minutes of sustained pressure loading at 12,000 psi; note the extensive lamination and partial separation of flange.

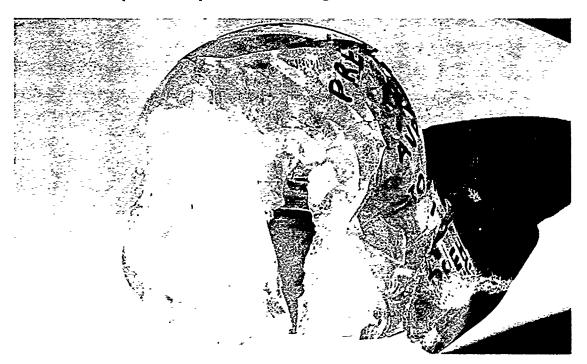
Figure 21. Same window as Figure 20; note the partial separation of flange and large scale plastic deformation midway between the flange and apex that led to the plastic instability failure of the window.

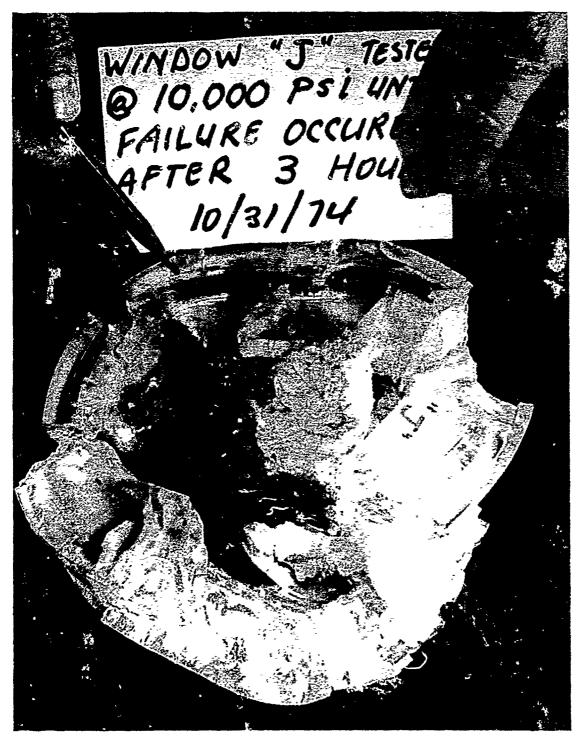
Figure 24. Window J, Type VI after 3 hours of sustained pressure loading at 10,000 psi; note the extensive lamination of the dome at the apex.

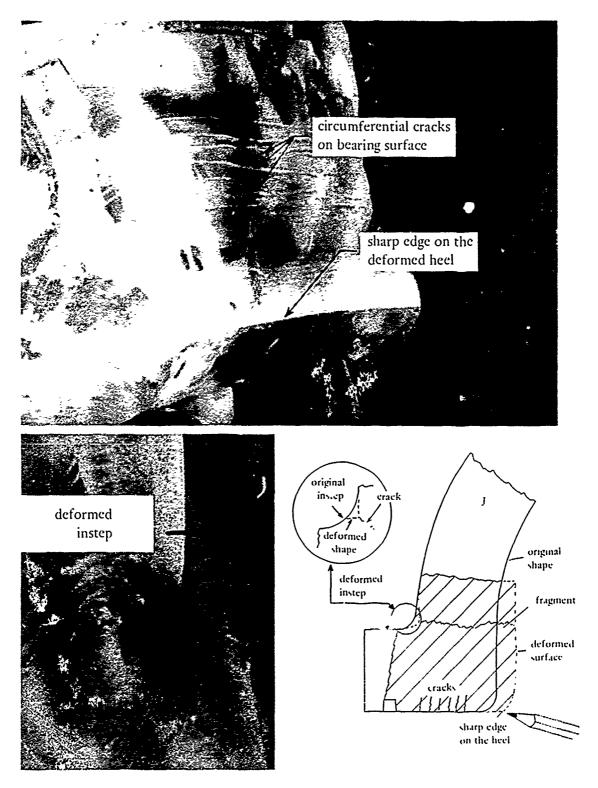
Figure 25. Same window as in Figure 24; note the presence of circumferential cracks in the bearing surface of the flange and the plastic transformation of the rounded heel into a sharp edge and the fillet on the instep into a sharp corner.

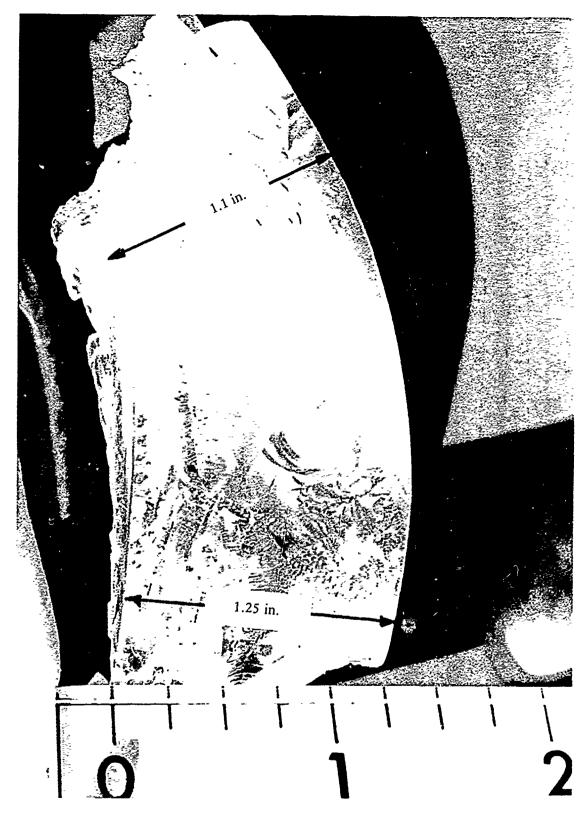
Figure 26. Window H, after 154 hours of sustained pressure loading at 8,000 psi; note the increase in wall thickness of the window near the flange due to plastic flow of acrylic under biaxial compression.

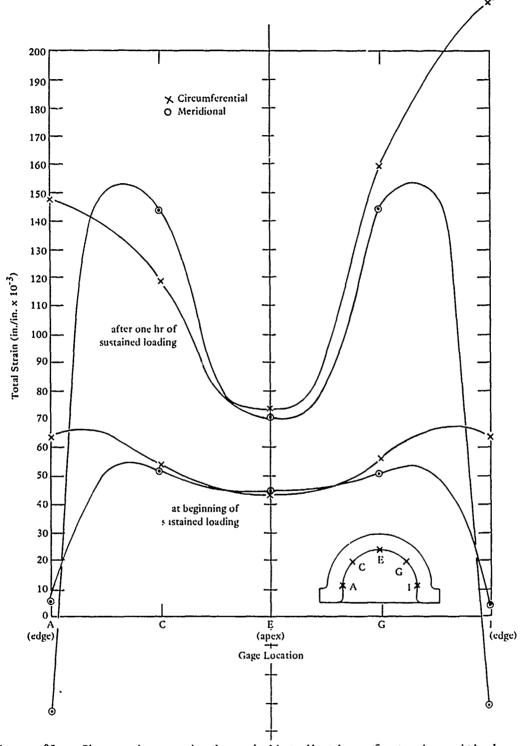
Figure 31. Change in magnitude and distribution of strains with duration of sustained pressure loading at 10,000 psi; window J, Type I; 75°F.

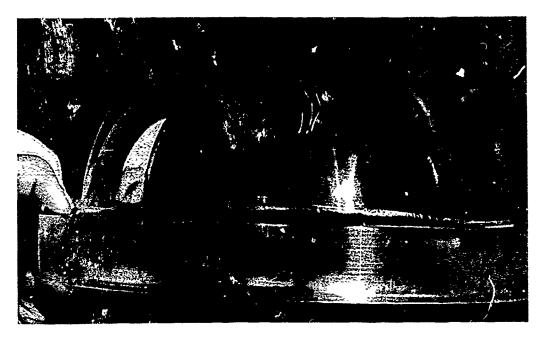
Figure 45. Same window as in Figure 44; note how the circumferential crack has penetrated the whole thickness of the flange.

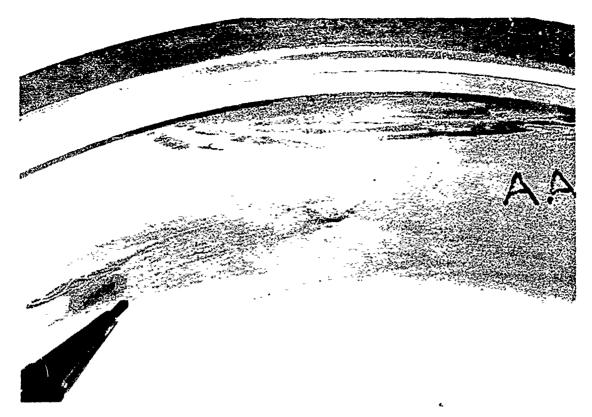
Figure 47. Same window as in Figures 39, 40, and 41; note that cyclic fatigue cracks on the flange bearing surface originating not at the 0-ring groove have a characteristic mushroom shape.

- (3) If cycling continued after appearance of crazing on the window seat, the crazing increased until eventually actual cracks were formed. The cracks always ran in the circumferential direction, sometimes in the O-ring groove but more often in the bearing surface between the heel of the flange and the O-ring. The cracks typically had a mushroom shape (Figures 39, 40, and 41).

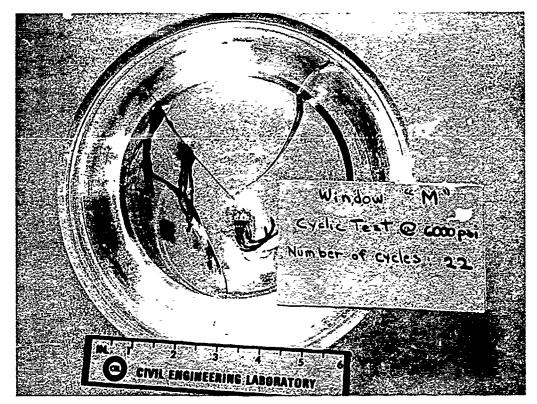
Figure 49. Typical cyclic fatigue meridional cracks on the interior face of window M, Type I window after 22 standard pressure cycles to 6,000 psi; note that the meridional cracks do not penetrate through the whole thickness of the window or flange.

- (8) In one case the buildup of tensile strain was the cause of severe cracking of the window's concave surface. The cracking occurred as the pressure was approaching zero during depressurization after 22 standard load cycles at 6,000 psi with the magnitude of tensile strain estimated at about 0.050 in./in. (Figures 49 and 50).

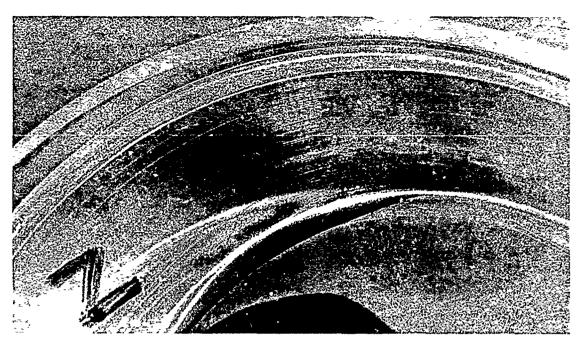
Figure 63. Window Z, Type VI after two standard pressure cycles to 8,000 psi on a neoprene-coated nylon cloth gasket and 200 hours of relaxation at 0 pressure. Note the absence of crazing at the termination of second pressure cycle (Figure 62).

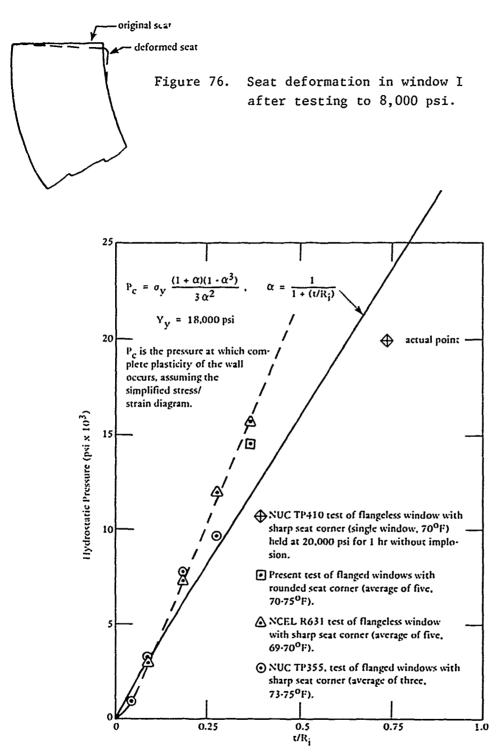
Figure 77. Comparison of actual and calculated critical pressures for hemispherical windows under short-term hydrostatic loading.

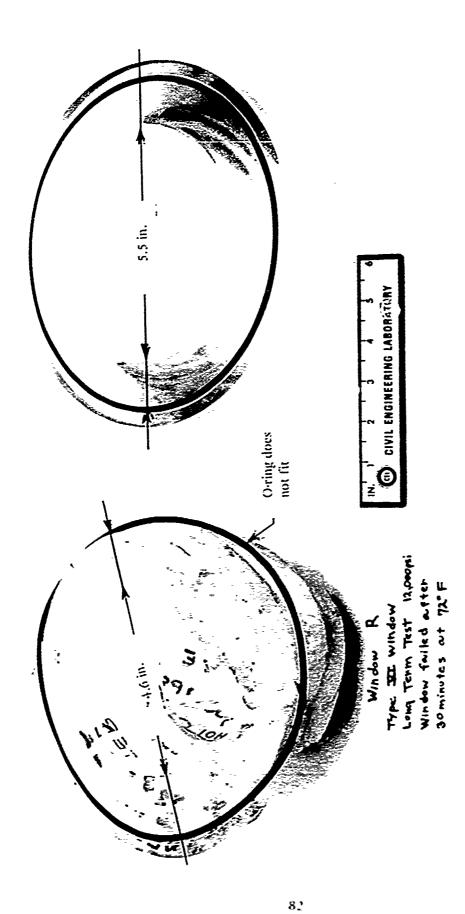
Figure 78. Plastic flow of acrylic plastic resulting in significant diametral deformation of windows prior to implosion under long-term pressure loading.
